2 Year Follow-up on Full Thickness, non-retracted Rotator Cuff Tear Treated with Stem Cells

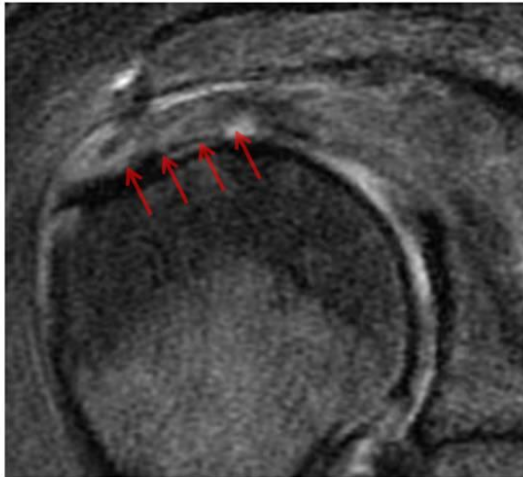
2.04.2008 COR MRI

COR MRI. ET=7, TR=2350, TE=62.2

Now for the patient MRI's. Above on the left is an MRI taken 2 months before her stem cell injection in April 2008, the image on the right is her 2 year follow-up MRI. The left MRI shows the rotator cuff tendon (red arrows) which is bright in color and mottled in appearance. This means that it's a full thickness rotator cuff tendon tear with severe degeneration (she's 78 years old at the time of this picture). To the right is her two year follow-up MRI showing a darker appearing rotator cuff tendon (yellow arrows) without any light color that goes all the way through the tendon (she's 80 years old in this picture). Clearly an improvement that's still holding and demonstrated not only by her reports of no pain and full function, but also objective MRI imaging two years later.

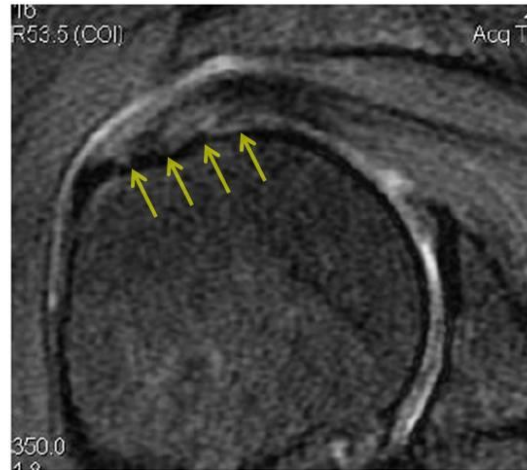
6.24.2010 COR MRI

COR MRI. ET=7, TR=2350, TE= 62
